CERTIFICATE OF COMPLETION AND SATISFACTION

Limited Microbial Investigation

Report #2385-A

Regarding: Eurofins Aerotech Built Environment Testing, Inc.
Project: 2385-A; 140 Granite Hills Rd, Kalispell
EML ID: 3223665

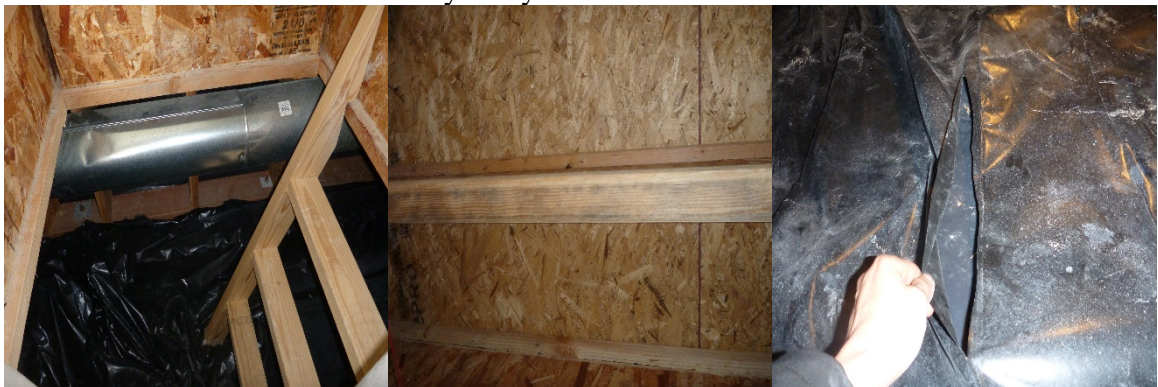
A visual inspection of the crawl-space underfloor area was conducted to identify evidence of past or on-going water intrusions, visible evidence of microbial growth or noticeable musty like odors. **Upon entering the crawl-space underfloor area a slight musty odor was observed. Further inspection of the crawl-space underfloor area revealed evidence of lite staining, perhaps caused damaged vapor barrier installed and/or prior or ongoing water intrusion in crawl-space underfloor space. Also, upon further investigation it appears that there is adequate ventilation in the crawl-space underfloor area, however, the 6-mil visqueen ground cover has been damaged in multiple locations. The ground cover that has been installed in this area is recommended to have some repair in order to help prevent and reduce moisture in the crawl space area. Note dry conditions did exist at time of this inspection and no visual evidence of past and/or ongoing moisture was found in the basement crawl-space underfloor area. Also, note the history of this structure is not known and/or if past moisture issues may have occurred which are no longer visible to inspection.** Also, note that this limited investigation is not intended to identify every area of microbial growth in the crawl-space underfloor area, but to provide a general overview of its condition related to possible microbial growth found in crawlspace area. Since it was not possible for our company to investigate the losses at the time of occurrence, it was necessary to rely on visual determinations, supplied information from the current homeowners and laboratory analysis.

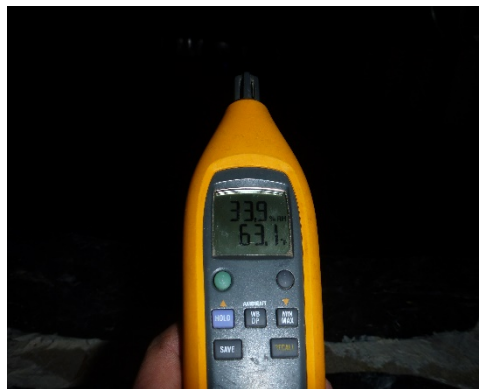
Location	Relative Humidity	Temperature
Crawlspace area	34 Percent	64 Degrees Fahrenheit

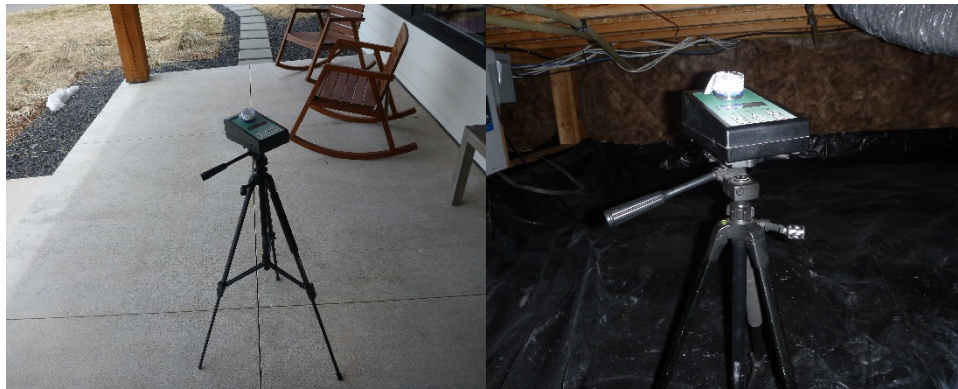
Sample #	Sample type	Location	Area
#1	ST (Non-Viable Bioaerosol Analysis)	Outside	Front Patio
#2	ST (Non-Viable Bioaerosol Analysis)	Crawlspace	NW Wing

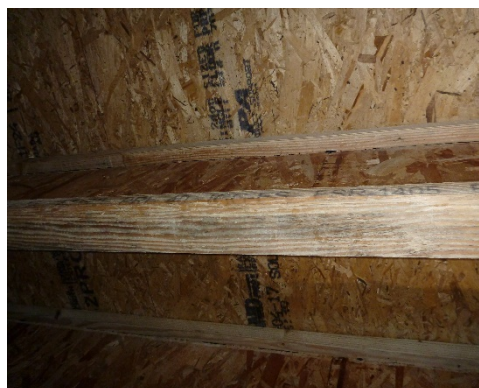
Sample #	Sample type	Location	Area
#3	SWB (Direct Microscopic Examination)	Crawlspace	Floor Joist Suspect

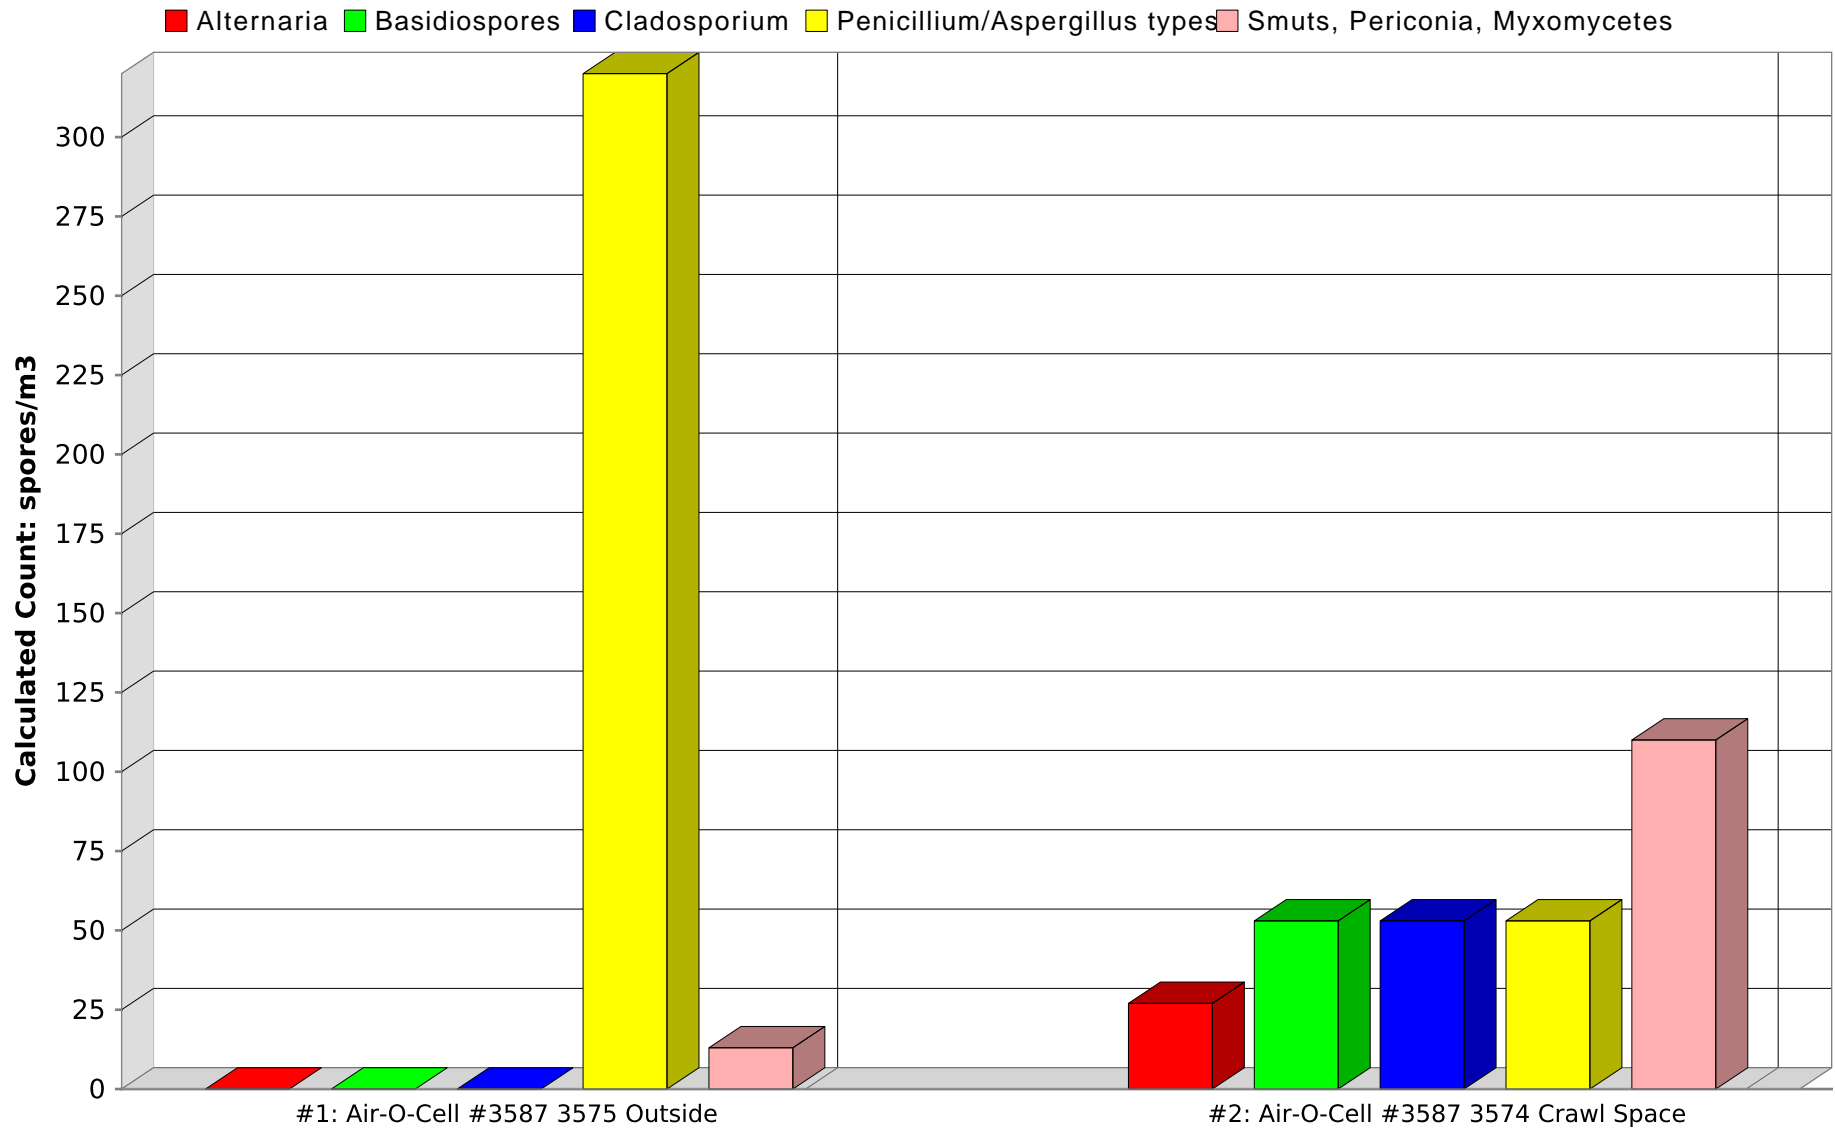
SPORE TRAP REPORT: NON-VIABLE METHODOLOGY

Note: Graphical output may understate the importance of certain "marker" genera.
Eurofins Aerotech Built Environment Testing, Inc.
